DAHUK REHABILITATION CENTER  
DAHUK, IRAQ

**SIGIR PA-06-070**  
**JANUARY 08, 2007**

SUBJECT: Report on Project Assessment of the Dahuk Rehabilitation Center, Dahuk,  
Iraq (Report Number SIGIR-PA-06-070)

## **Dahuk Rehabilitation Center Dahuk, Iraq**

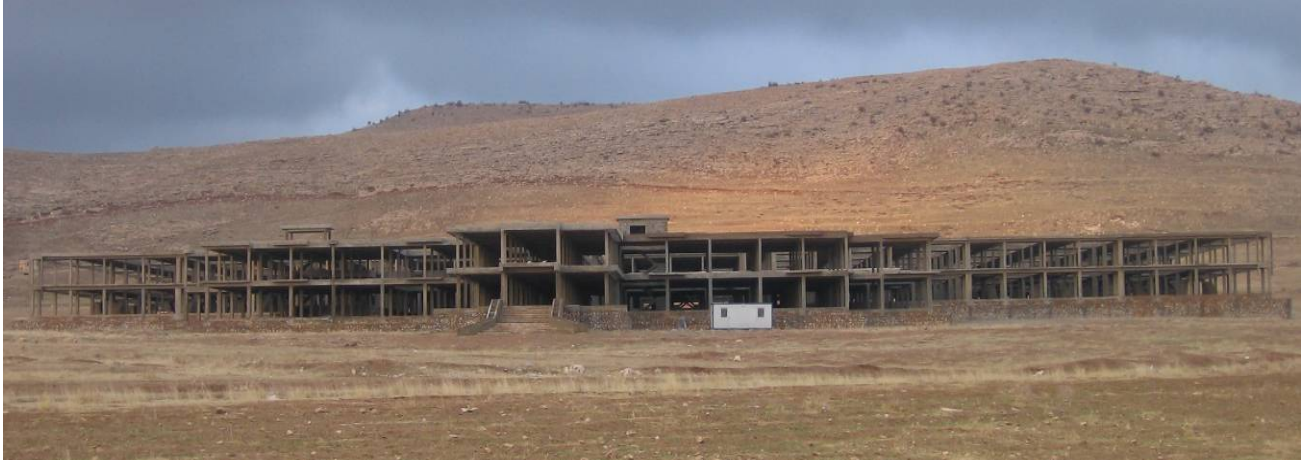
At the time of the site assessment, the project was reported as 60% complete. The facility’s structural concrete framework was completed before the project was halted in 2001. Accordingly, the concrete skeleton from the previous work served as a starting point for new construction covered by the current contract. The photo below, courtesy of the U.S. Army Corps of Engineers (USACE) dated 26 December 2005, shows the concrete framework previously completed.

**The Dahuk Rehab Facility at the pre-construction stage for the current contract.  
(Photo courtesy USACE.)**

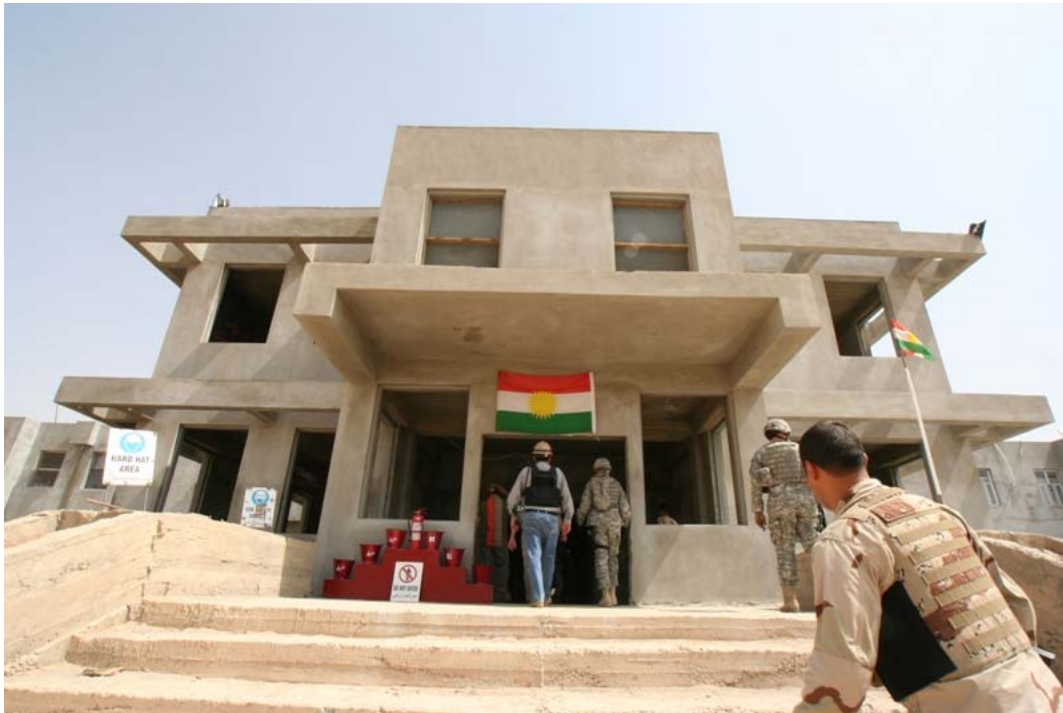
**Site Photo 1. Main entrance to the Dahuk Rehabilitation Facility.**

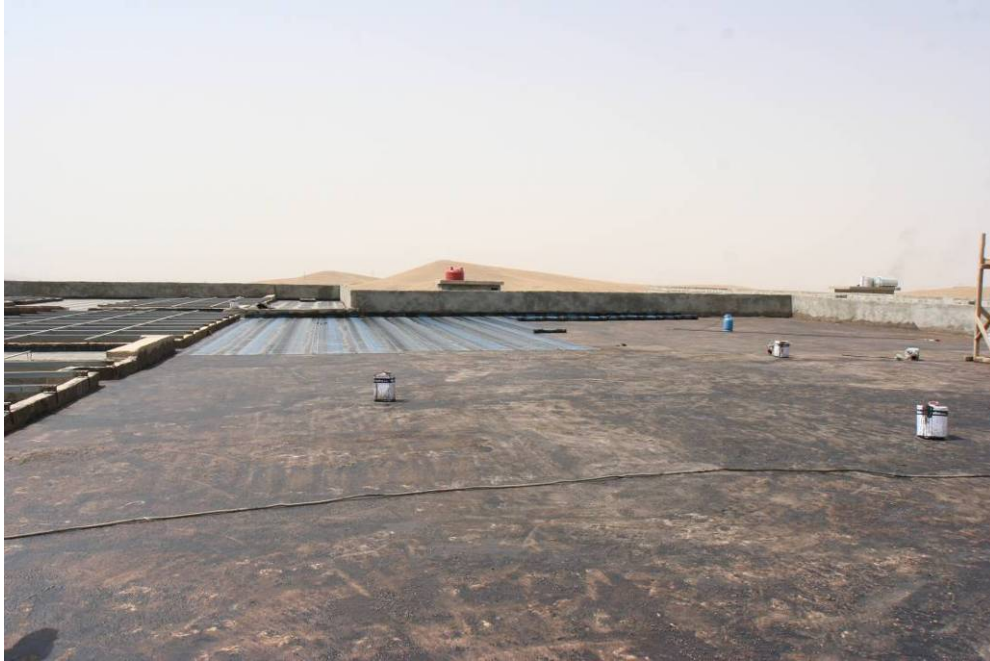
Work on the facility is divided into two levels and a roof. To weatherize the roof surface of the building, the contractor applied a multi-layered bituminous sealant waterproofing membrane coating to the roof. The initial bituminous layer was applied in a liquid form to serve as a primer for subsequent rolled material layers. Site Photo 2 shows the thorough application of liquid bituminous primer to the roof.

**Site Photo 2. In the forefront, a first layer of primer/sealer was applied in liquid form.**

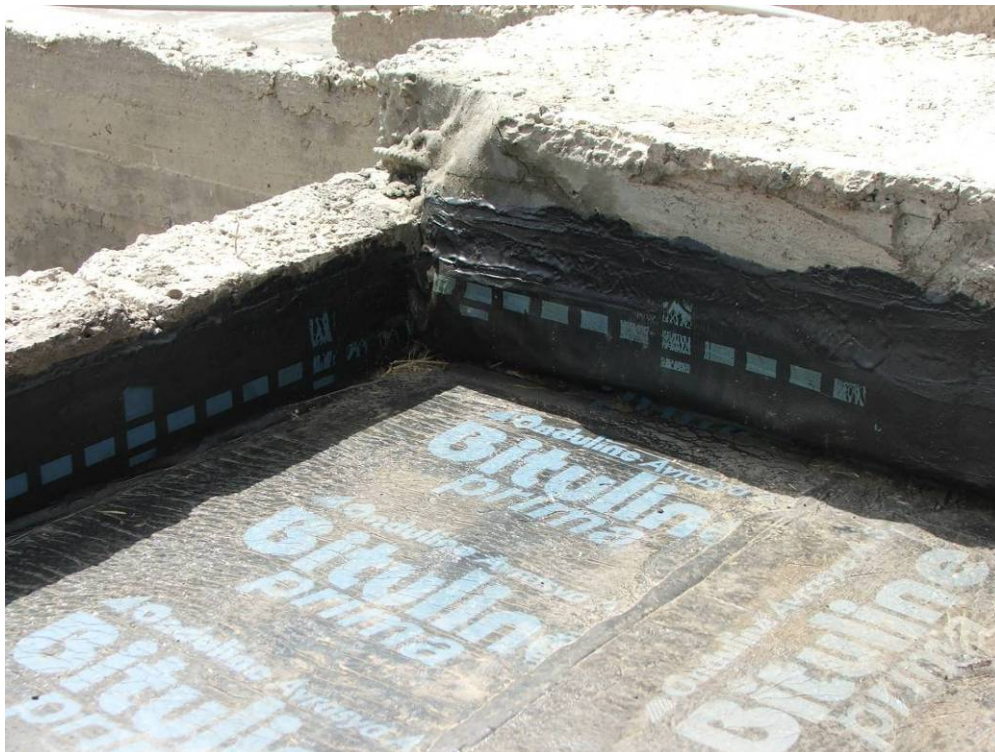
Application of the bituminous waterproofing membrane was applied as the last step in the process. The roll material membrane, approximately a meter wide, was applied using a “torch-on” hot material technique to securely attach the membrane to the roof surface. Site Photo 3 shows the evenness of the overlapping seam and the flat lie of the membrane. In addition, the membrane material appeared free from voids and pockets, and was cleanly attached to the geometry of the inner roof corner.

**Site Photo 3. Bituminous waterproofing membrane.**

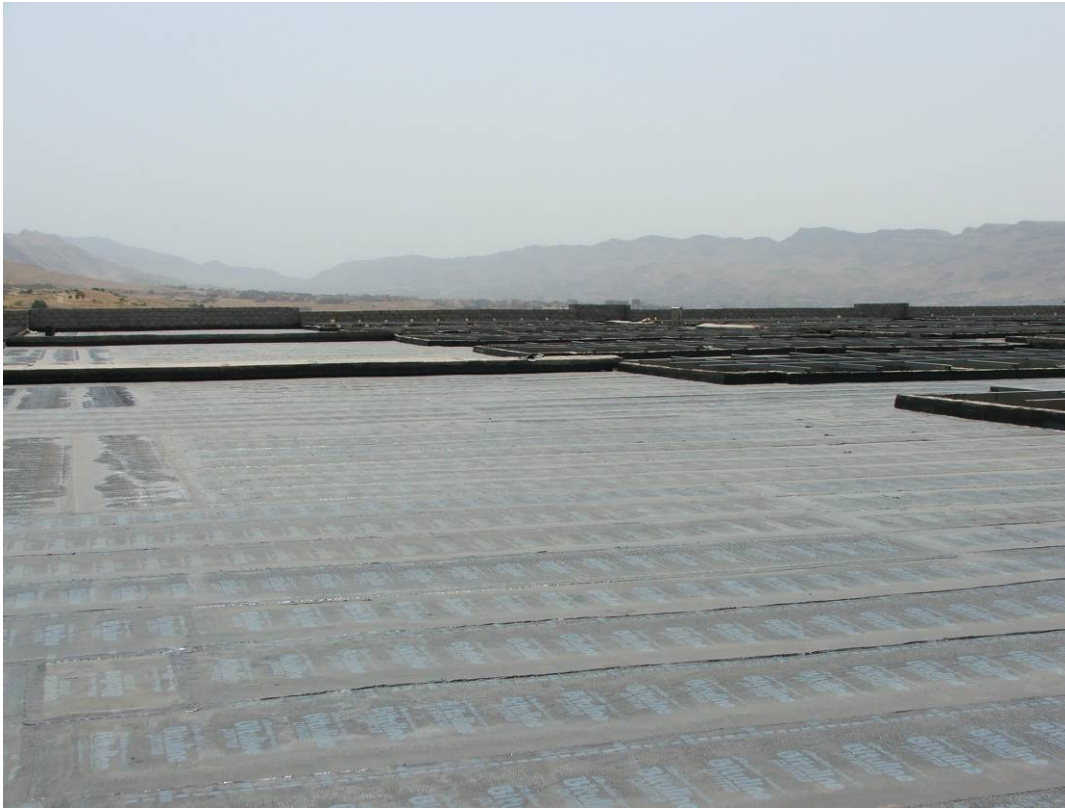
Site Photo 4 is a large scope display of the membrane's adhesiveness to the roof forming a strong membrane surface bond along with even seams. Based on the assessment team's observation, the membrane was properly installed and evenly distributed with straight and parallel seams over the entire roof.

**Site Photo 4. Large scale view of bituminous waterproofing membrane.**

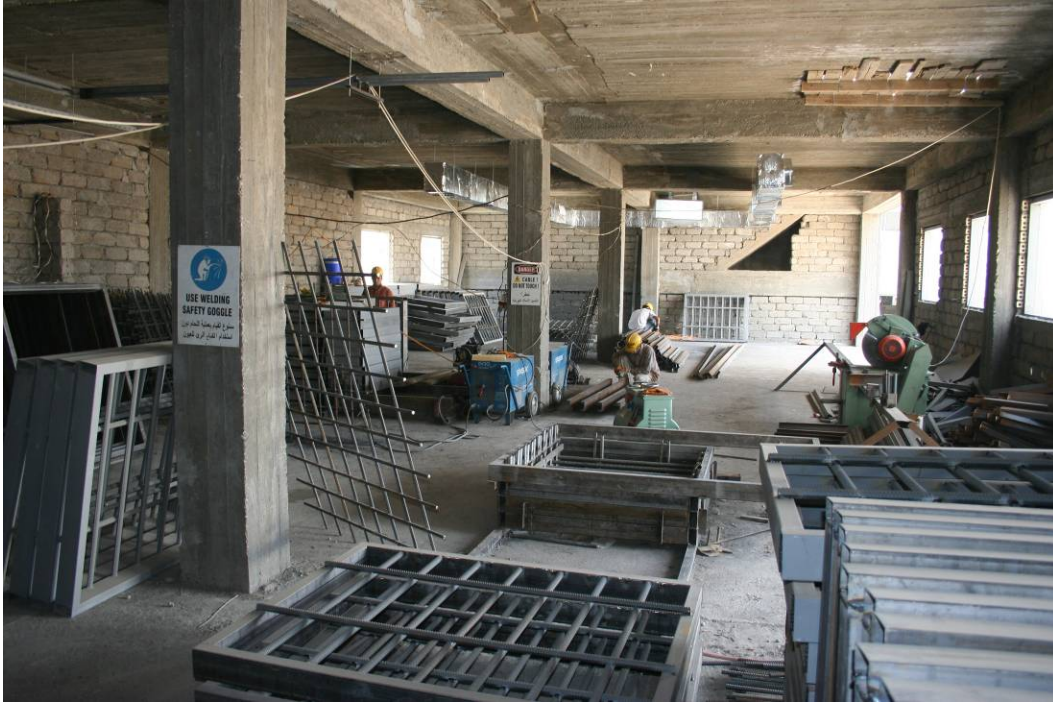
The contractor established a fabrication room to construct reinforced frames with metal bars for windows and doors. This room became the manufacturing and inventory center for all security bars to be installed throughout the rehabilitation facility. Using a variety of metal working tools, the contractor fabricated security protection bars for windows, doors, and other openings from raw metal stock in a shop environment to control quality. Site Photo 5 displays the pre-fabrication shop where workers ground, cut, and welded raw steel in order to build opening frames and protection bar assemblies that were uniform and square.

**Site Photo 5. Pre-fabrication shop for security protection bar assemblies.**

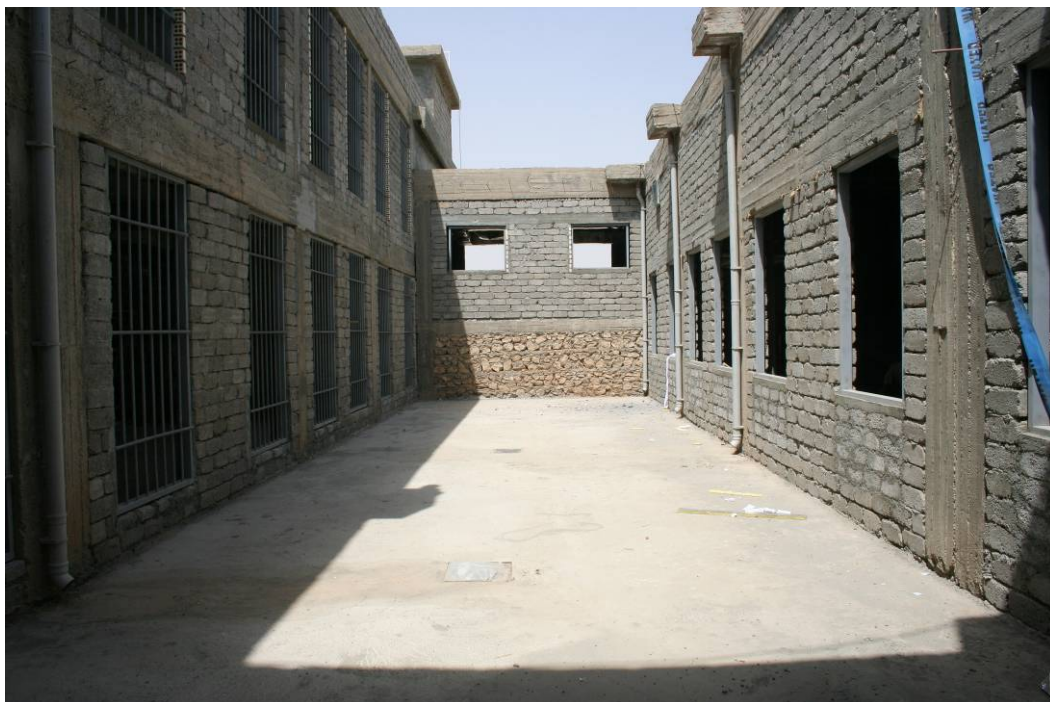
Installation of the pre-fabricated protection bars throughout the facility was the next construction step observed by the assessment team. In Site Photo 6, security protection bars were installed in the large windows on the left side of the picture while the smaller windows on the right side were pending installation.

**Site Photo 6. Ground floor installation of security protection bar assemblies.**

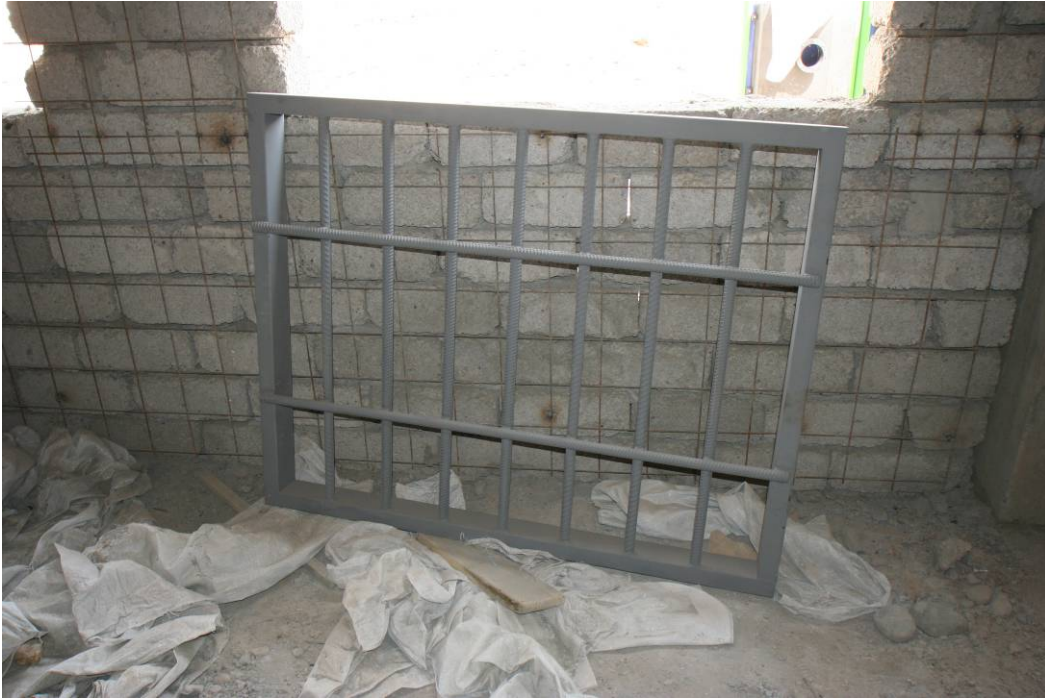
Security protection bar assemblies were manufactured in the shop to fit the various opening sizes throughout the facility. Site Photo 7 shows the inside of a window waiting the installation of a pre-fabricated protection bar assembly. The assessment team observed that security bar spacing was uniform within the frame and the assembly was painted before installation in an effort to reduce future corrosion. In addition, steel reinforcement mesh was installed inside the concrete masonry unit (CMU) wall.

**Site Photo 7. Pre-fabricated security protection bar assembly staged for installation.**

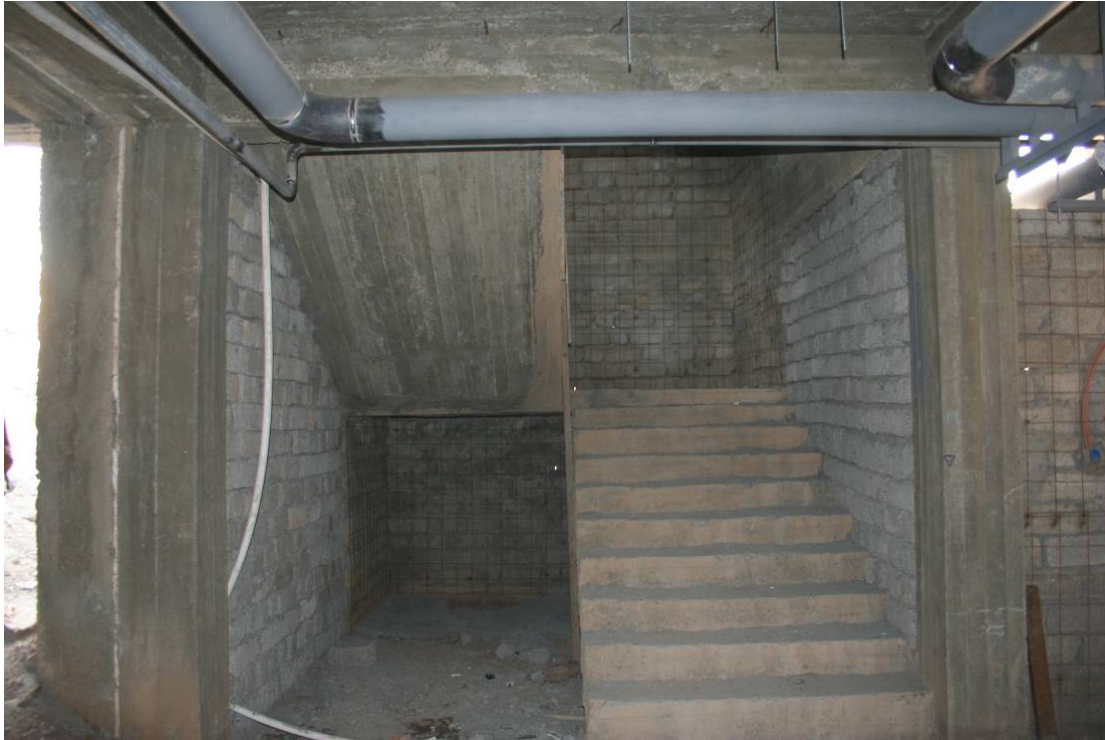
Site Photos 8 and 9 show stairwells in pre-finished condition. Site Photo 8 shows steel reinforcement mesh attached to the exterior of the Concrete Masonry Unit (CMU) wall awaiting application of the finishing layer of concrete. The mesh will improve bonding between the CMU wall and the finish layer while reducing cracking in the finish layer. Site Photos 8 and 9 show that the steps were cast level and square. In addition, the absence of concrete separation or honey-combing attests to the structural integrity of the casting.

**Site Photo 8. Pre-finish front view of poured concrete stairs.**

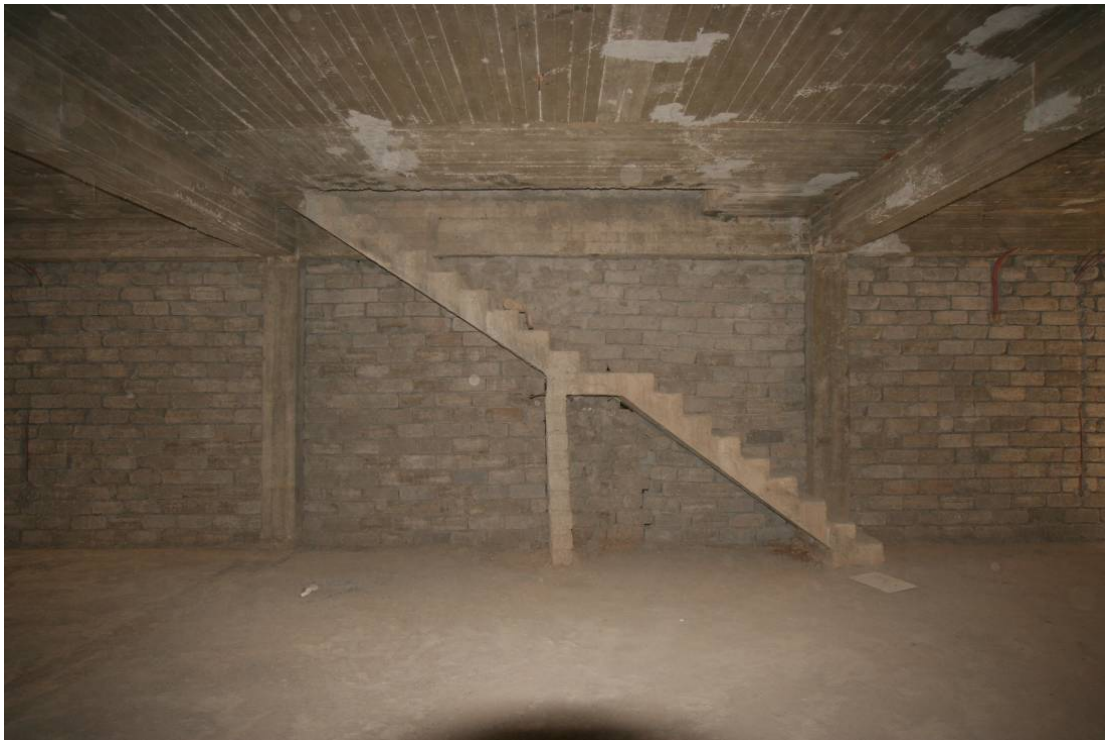
**Site Photo 9. Pre-finish side view of poured concrete stairs.**

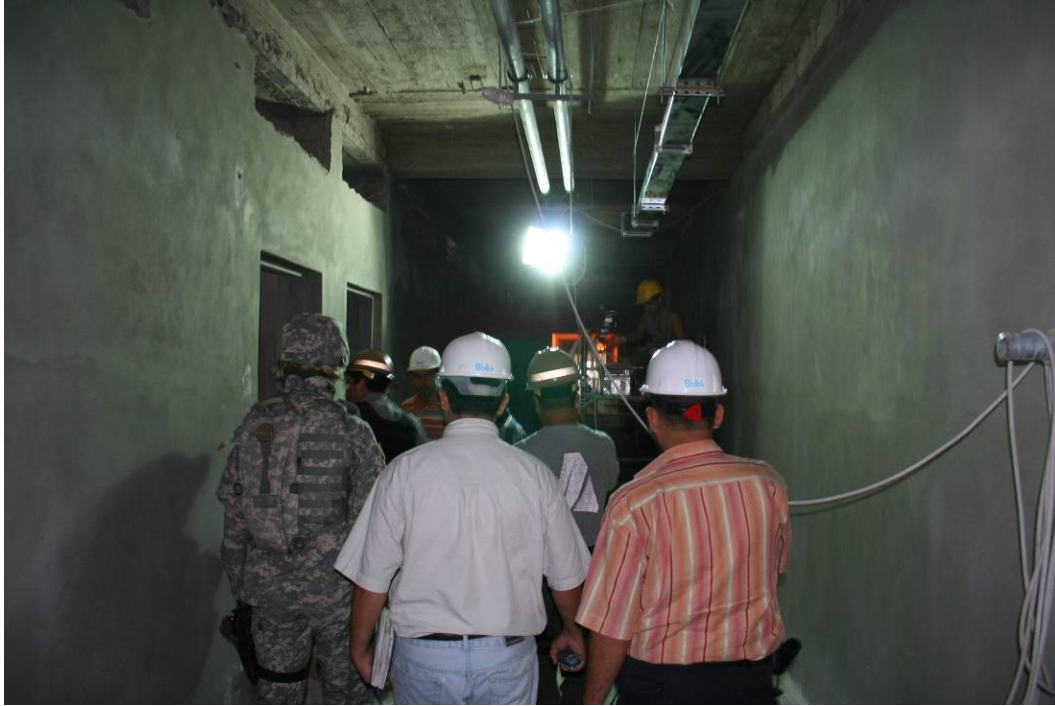
**Site Photo 11. Concrete finished interior walls.**

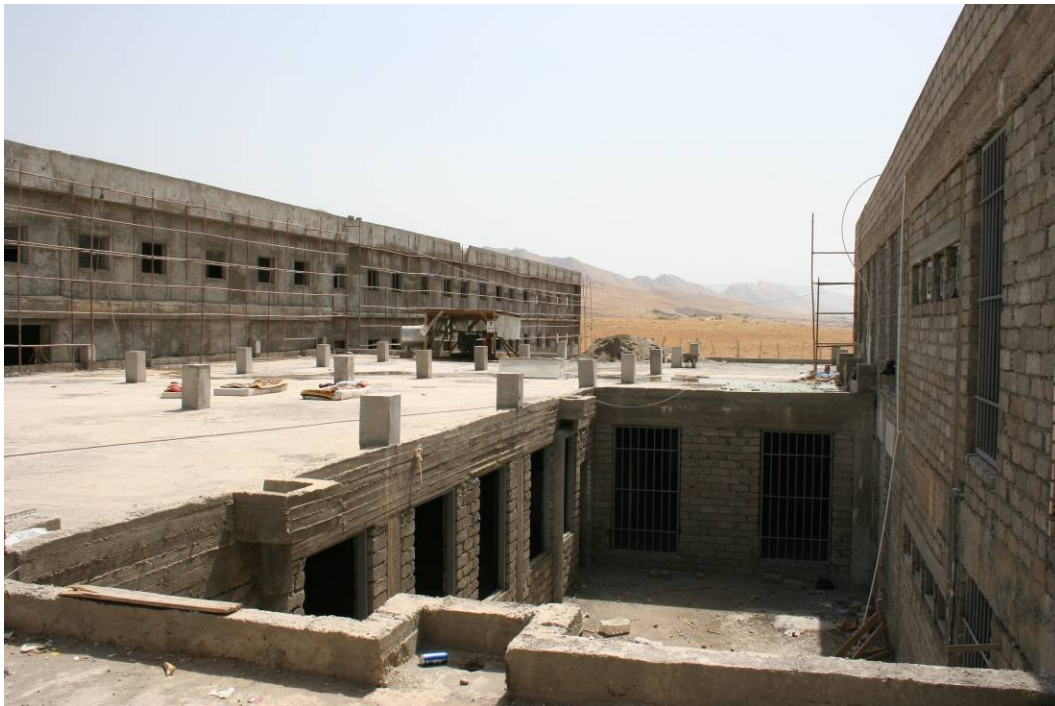
**Site Photo 12. Left side of photo shows completed exterior finish work, while right side shows an unfinished wall.**

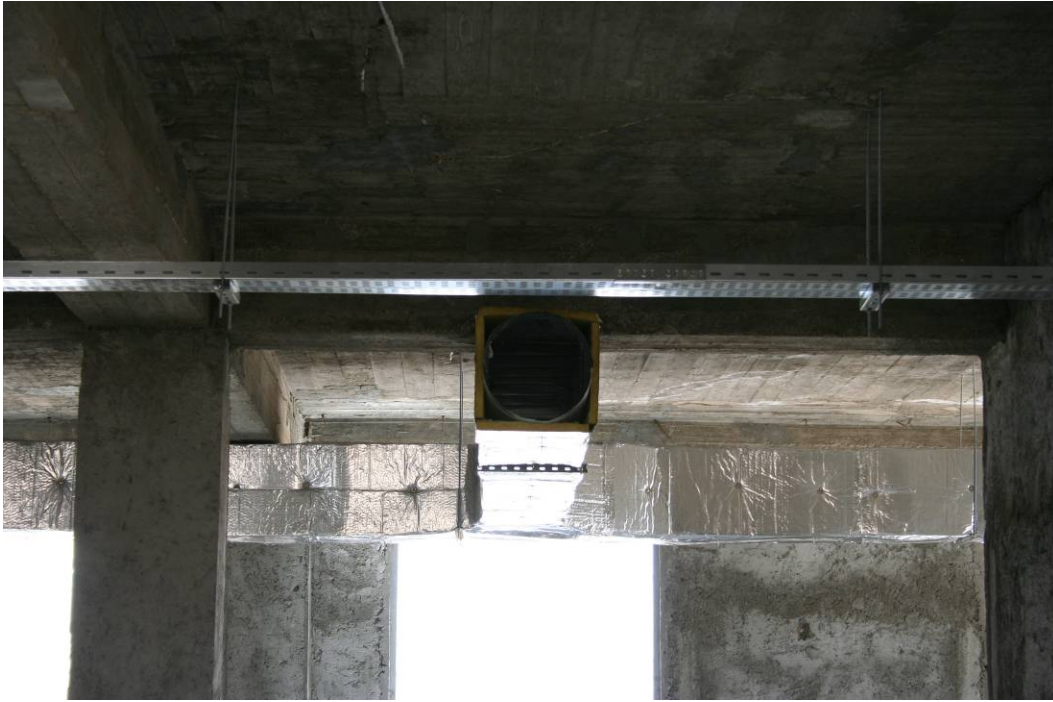
Site Photo 16 shows an insulated duct and cable tray attached to the ceiling in preparation of final construction. During the site assessment, the inspectors observed that the ducts, trays, and pipes were hung with hangers and were attached an equal distance apart and level. In addition, hangers appeared to be made with new materials of sufficient size.

**Site Photo 16. Ducts and cable trays throughout the facility appeared professionally installed.**

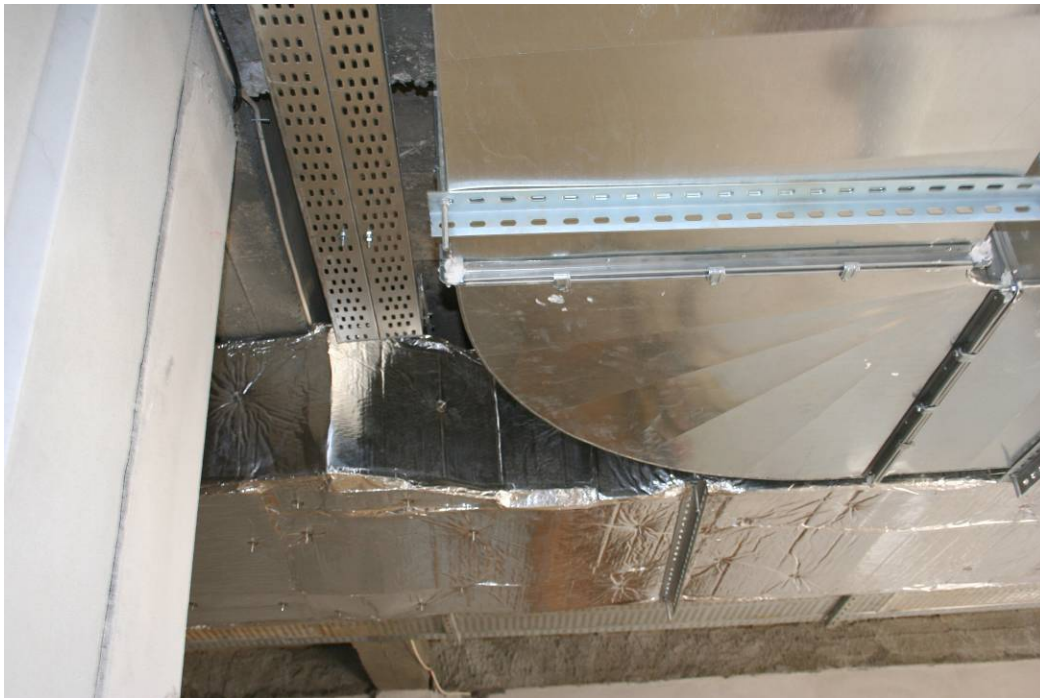
Site Photo 17 shows the professional construction techniques used throughout the facility to install cable trays and ducts. Duct insulation wrap appeared complete and smooth. All cable trays and ductwork observed were level and hung an equal distance from the ceiling.

**Site Photo 17. Cable tray and duct work were neatly installed in a confined area.**

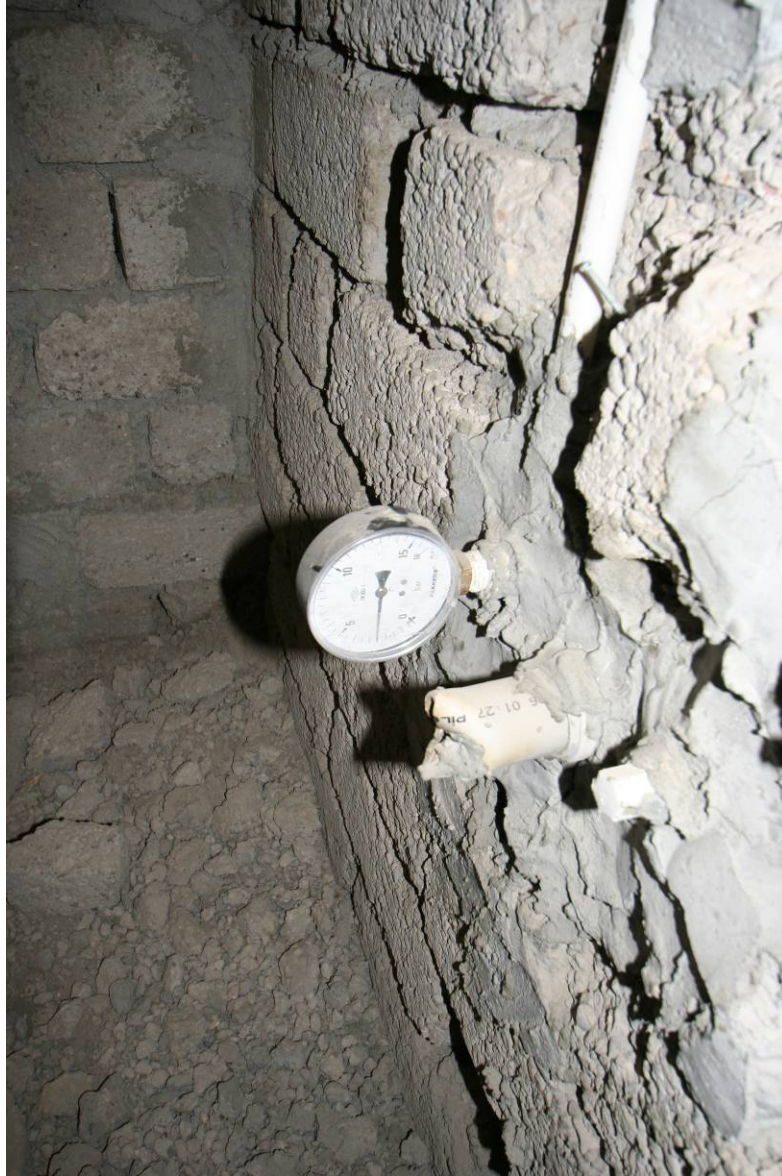
At the time of the assessment team's visit, the installation of the wastewater pipes, rainwater pipes, and domestic water supply system pipes were complete. The contractor was in the process of conducting pressure tests on the domestic water supply system pipes. In Site Photo 18, a pressure meter is attached to a pressurized domestic water line.

**Site Photo 18. Domestic water line pressure test was in progress.**

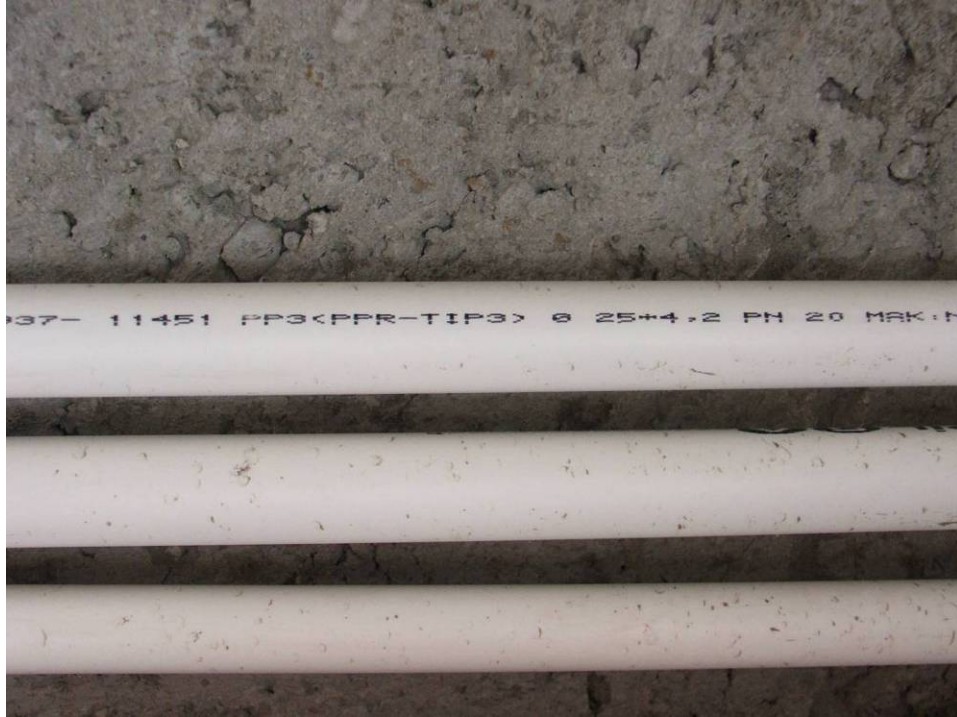
Site Photo 19 is a close-up of an exposed section of domestic water supply system (cold, hot, and circulation lines) PolyVinylChloride (PVC) pipe. After successful pressure testing, the exposed piping can be covered with plaster as part of the finishing process. The RE confirmed that a record of successful pressure tests was retained to document completed pressure testing throughout the facility. In addition, coding on the pipe documented that the pipe met requirements.

**Site Photo 19. PVC pipe was used for most domestic water pipe (cold, hot, and circulation) applications.**

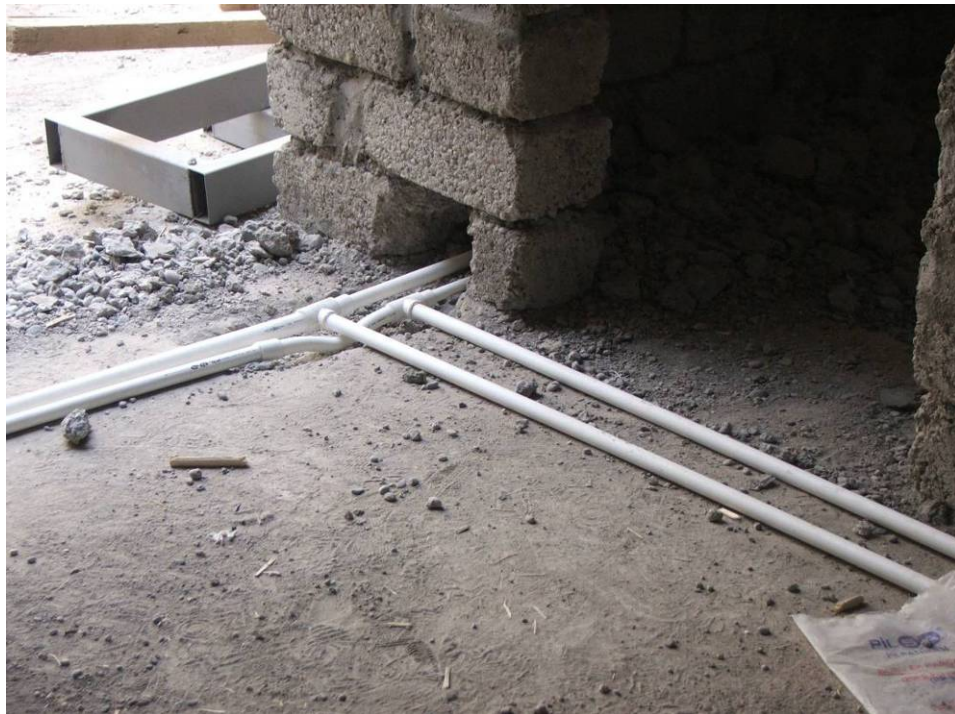
In Site Photos 20 and 21, domestic water piping runs along the floor and wall of a bathroom area waiting successful pressure testing before applicable wall or floor finishing could be completed. The photo shows even installation of clean new PVC piping. In addition, the pipes were fitted cleanly together in a professional manner.

**Site Photo 20. PVC pipe run along the floor was pressure tested before installation of floor tile.**

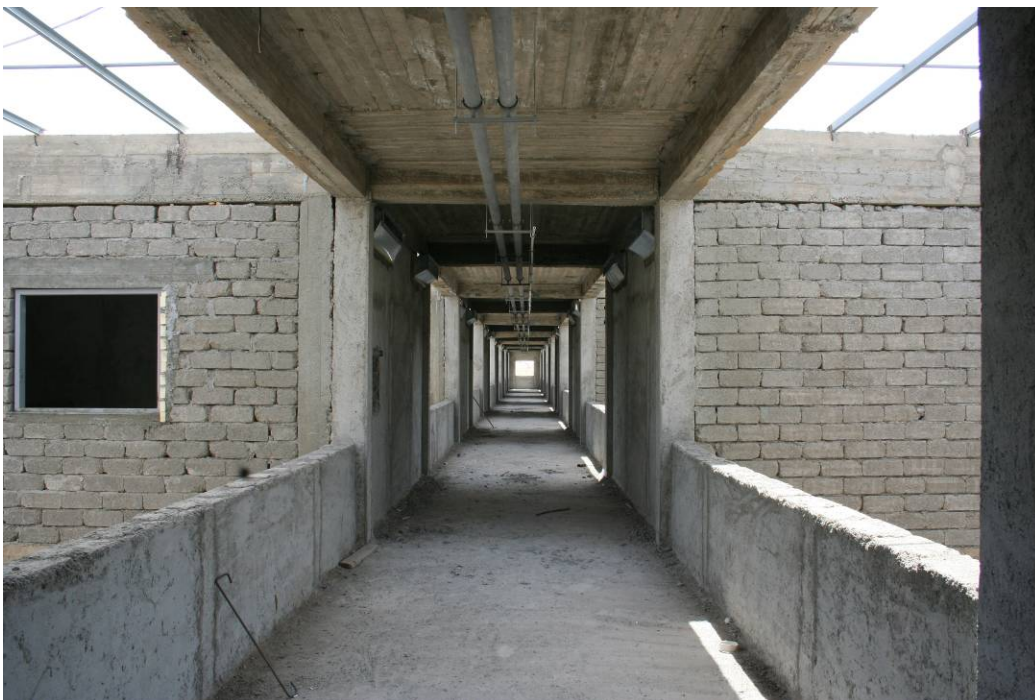
While not completed at the time of the assessment team's visit, pipe work installation for a firefighting system was in progress. In Site Photo 22, piping for the firefighting system was hung from a corridor ceiling. As with the cable trays and ductwork, firefighting piping was placed in parallel on evenly spaced hangers.

**Site Photo 22. Corridor contains firefighting system piping.**

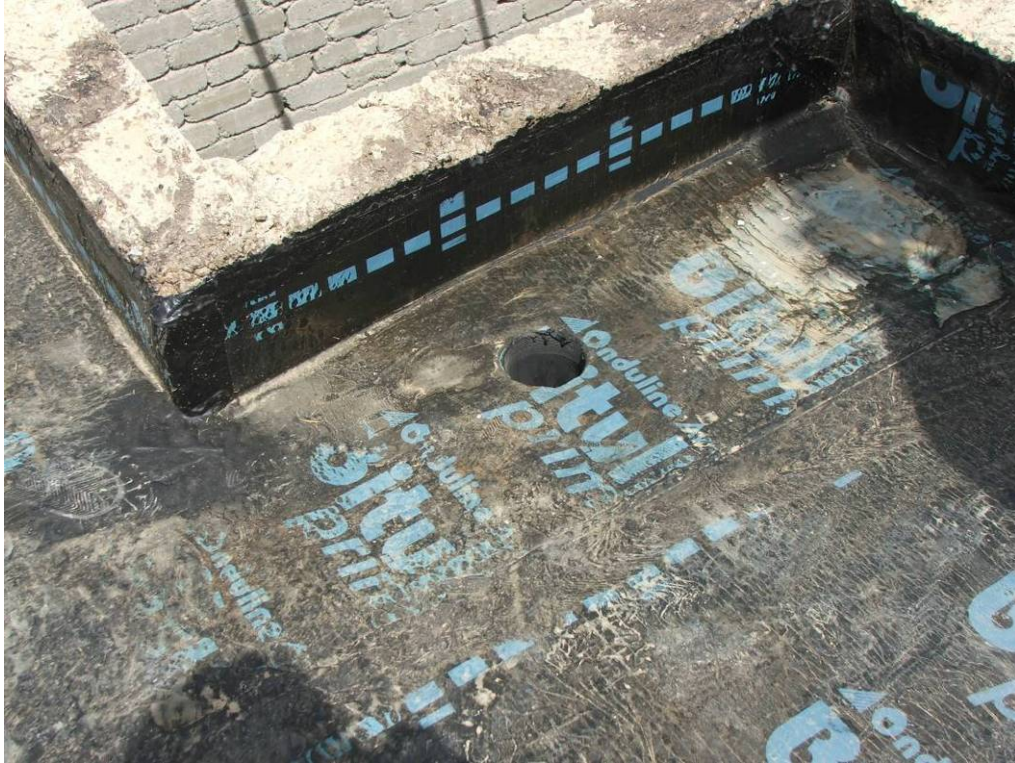
Installation of rainwater piping was completed by the time of the assessment team's site visit. Site Photo 23 shows the basin on the topside of the roof where the rainwater will collect and Site Photo 24 shows the positive connection rainwater piping used to drain the roof. It appeared that the drain pipe was securely attached to the wall.

**Site Photo 23. Topside view of rainwater collection basin with drain piping.**

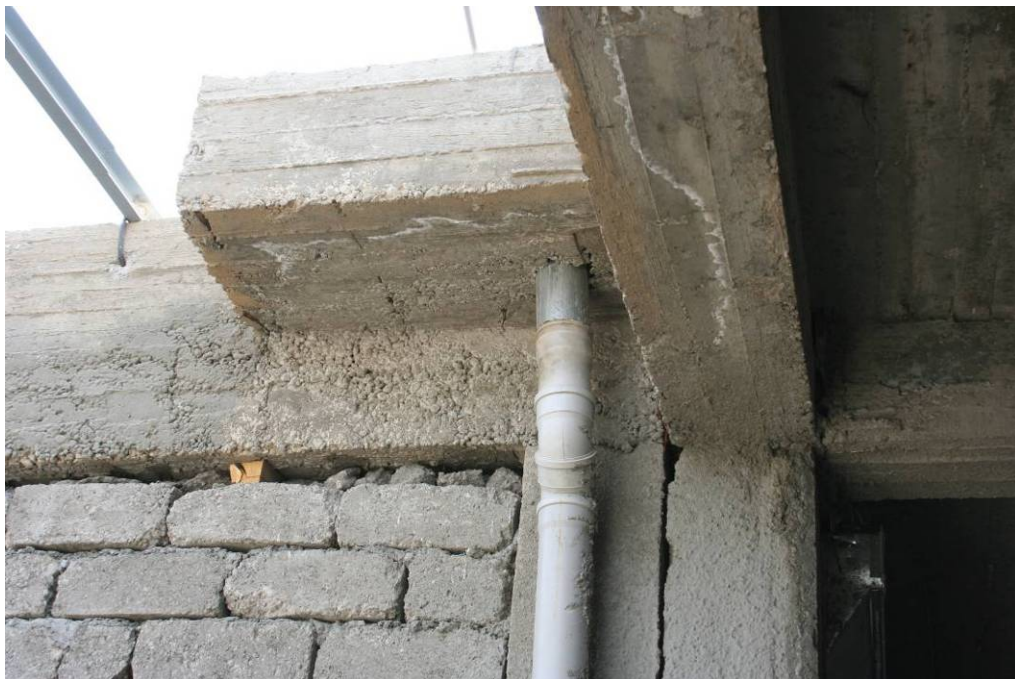
**Site Photo 24. Bottom side view of collection basin showing positive rainwater drain piping.**
